Analysis of Damages Caused by Earthquakes to Traffic Facilities in Mountainous of West China

Abstract: The paper lists the types of direct and indirect damages to roads, bridges, tunnels caused by the earthquake in mountainous areas in the west of China, and the reasons for damages are analysed. Due to the steep mountain terrain, poor geological conditions, the limit of the local economic development level, the lack of design for anti-seismic or an inadequate consideration of seismic level along with the relative low level of the construction technology, the damages from the earthquake are particularly severe in mountain areas.

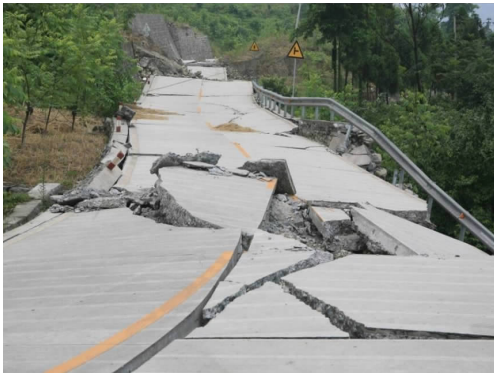
The main damage forms of road bed and pavement to road are overall fracture, dislocation and slip^[2]. Road bed damage forms are road bed rupture and slip, the main damage forms of pavement are pavement cracking, cement concrete pavement surface buckling, etc. Serious damage of subgrade and pavement in Wenchuan Earthquake is shown in Fig. 1.

Fig. 1 Highway roadbed of severe earthquake damage

Overall settlement of roadbed and pavement is one of the common damages in earthquake epicenters, and the main causes of this damage are as following:

(1) The seismic waves cause the liquefaction of the roadbed base, and form a large roadbed subsidence area. Typical sections are mainly located in the roadbed which is filled with sand or gravel in high water table area^[6].

(2) Due to the uneven of the filling body or soil mechanical properties of the roadbed, the seismic waves cause uneven settlement of roadbed soil and result in overall sub-

sidence of pavement and roadbed in some areas. The typical sections are mainly at abutment, culvert back, wall back fill embankment, vertical and horizontal cut and filled transition sections^[6].

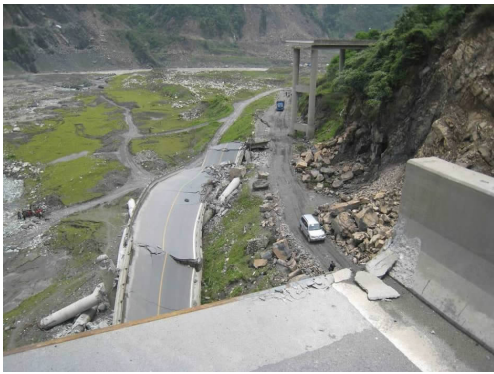
The Baihua Bridge is severely damaged in Wenchuan Earthquake, which mainly included the collapse of the global structure of the fifth continuous girder unit, damage to the substructure and superstructure of the Bridge. The Baihua Bridge collapsed in Wenchuan Earthquake is shown in Fig. 2.

Fig. 2 The collapsed Baihua Bridge in Wenchuan Earthquake

There are generally two reasons for beam falling; one is due to the abutment pier slip to the channel direction, when slide momentum is too large, the broken bridge pier leads to the fall to the ground; another is the destruction of the bearing beam, leading to the fall to the ground of beam^[7].

Though construction of simply supported beam bridge is easy, but the earthquake resistant ability is poor, which is mentioned above as the Baihua Bridge.

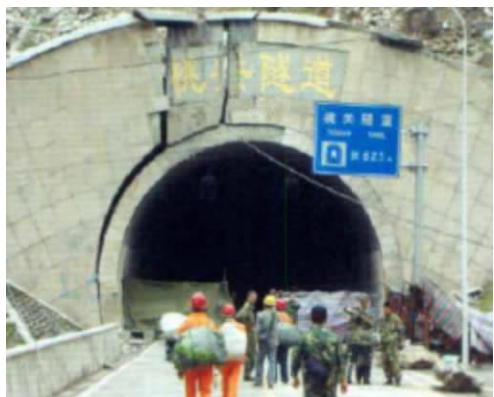
The earthquake caused great damages to the tunnel portals and lining, for example, the portal walls of the Tao Ping tunnel broke up which is on the road from Dujiangyan to Wen chuan.

Fig. 3 Breaking up of the portal walls of the Tao Ping tunnel

In addition to seismic force, portal and fault movement caused by earthquake is external cause of the damage of tunnels. Generally speaking, the tunnel portal back slope destruction has greater influence on traffic facilities^[2].

In the Wenchuan earthquake, the intensity at epicenter is much larger than the fortification intensity of the original design for the tunnel lining structure. The slopes' collapse at the entrance of the tunnels is mainly because that the entrance slope is too steep and extremely high.

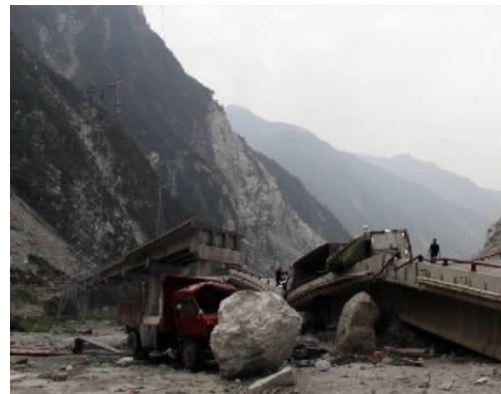
And then, the ongoing collapse after the earthquake caused damage of Bridges. On July 25, 2009, the bridge on national road 213 was smashed up completely by crumble, causing about 100-meter bridge to collapse, which is shown in Fig. 4.

Fig. 4 The Chediguan Bridge smashed up by boulder

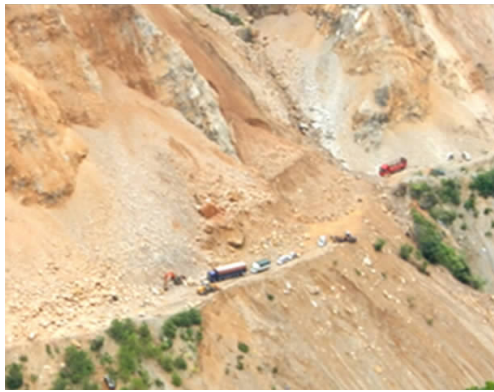
Road in the epicentral area were buried by land slip after Ludian Earthquake, which is shown in Fig. 5.

Fig.5 Land slip plug road

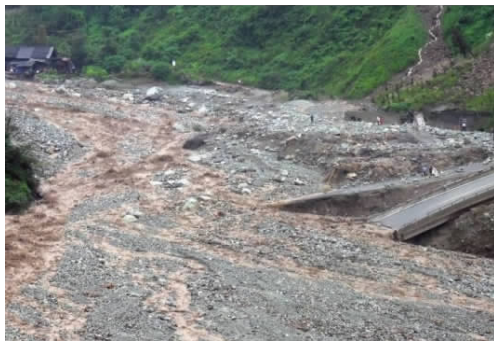
Two years after Wenchuan Earthquake, there were outbreak of stony mud avalanches in Dujiangyan (on Aug, 13th), and Yingxiu (on Aug, 14th), resulting in large-scale disasters^[2]. The roads having been damaged by the debris flow is shown in Fig. 6.

Fig.6 Road is hit by the debris flow after Wenchuan Earthquake
